NORSOK N-005 Integrity management of offshore structures and marine systems

# Surveillance, evaluation, mitigation, repair and strengthening

- Integrity management process
- Surveillance programs
- Examples from an FPSO on the NCS
  - Inspection
  - Evaluation
  - Mitigation

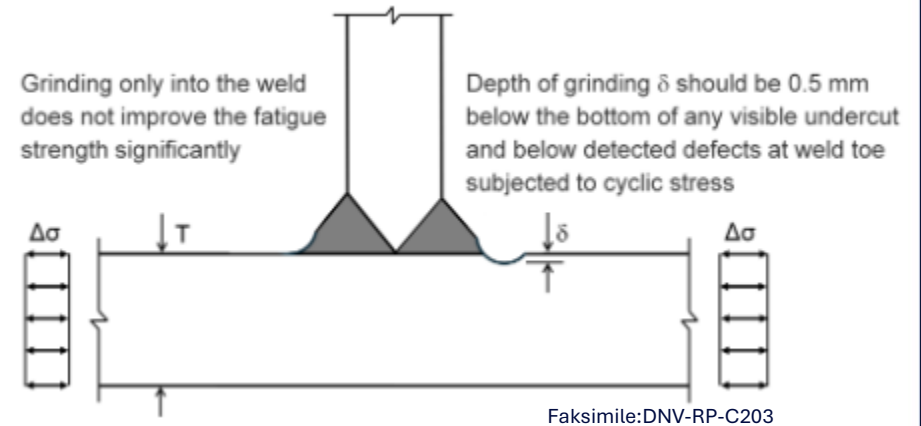
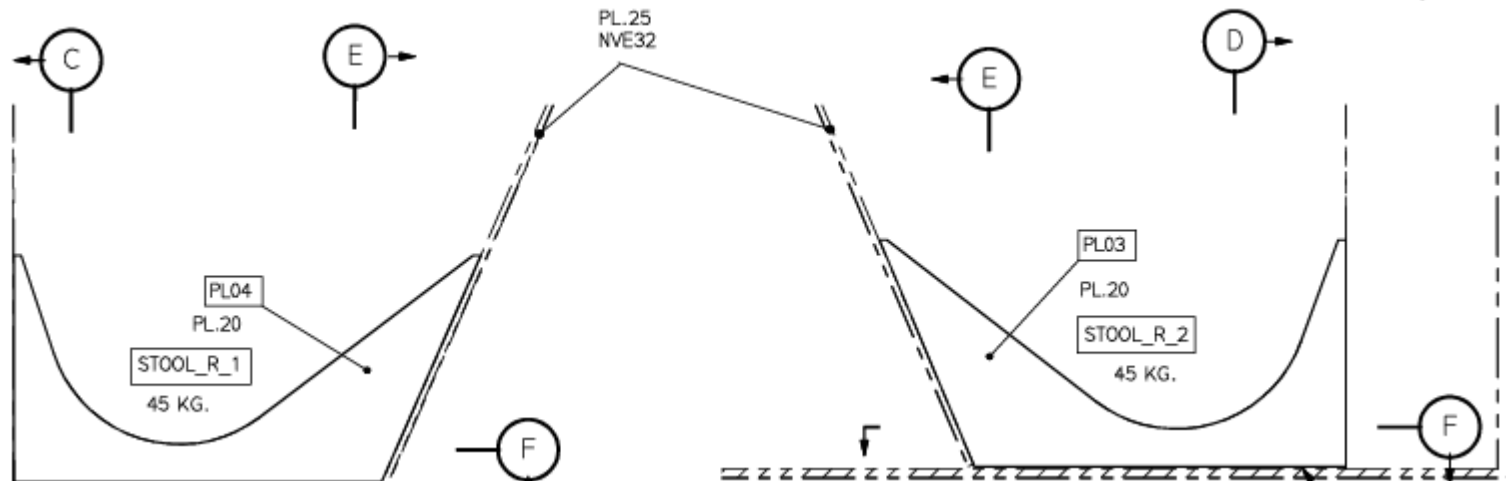
- Section 13  
Mitigations, repair and strengthening
  - Grinding (according to DNV-RP-C203) performed at 53 locations
  - Weld repair at two locations
